**O & M INSPECTION REPORT
FOR NAVIGATION AND SHORE PROTECTION PROJECTS**

1. Project Name: Kawaihae Small Boat Harbor

2. Date of Inspection: May 7, 2002

West Breakwater 1,260LF:

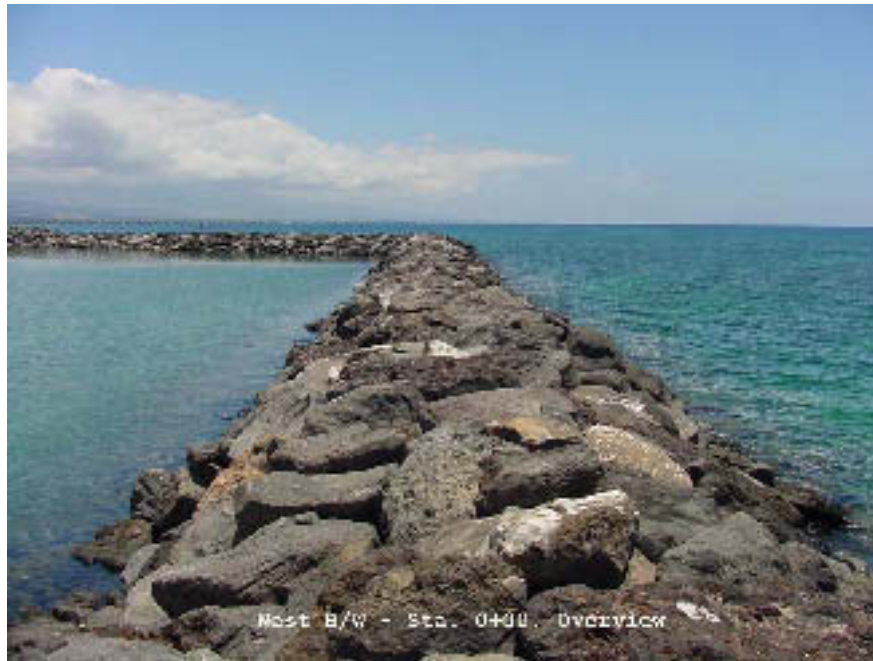
a. Sta. 0+00, Overview photo for reference.

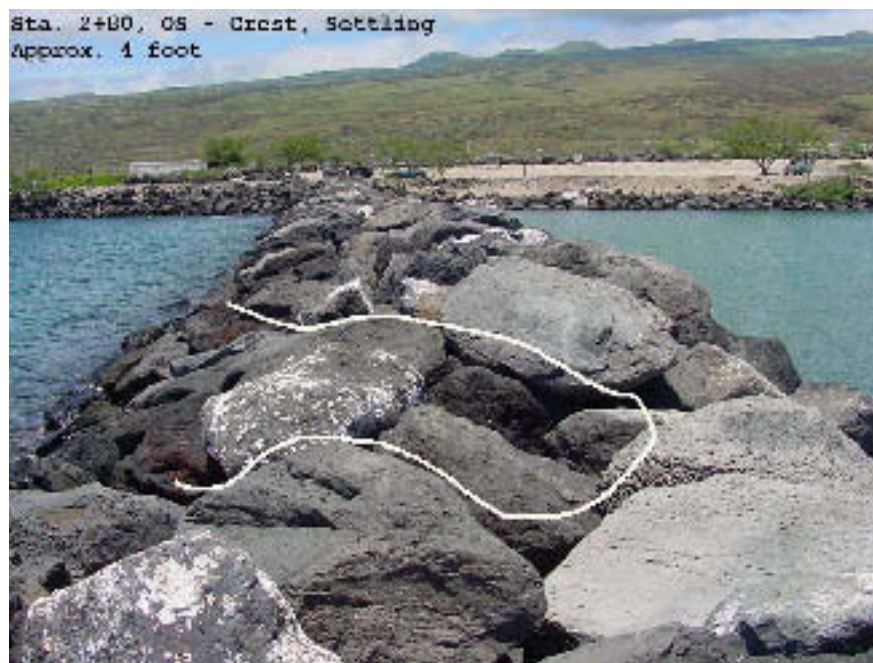
b. Sta. 2+80, OS - Crest, Settling of armor stones approx. 4' deep. Monitor this area.

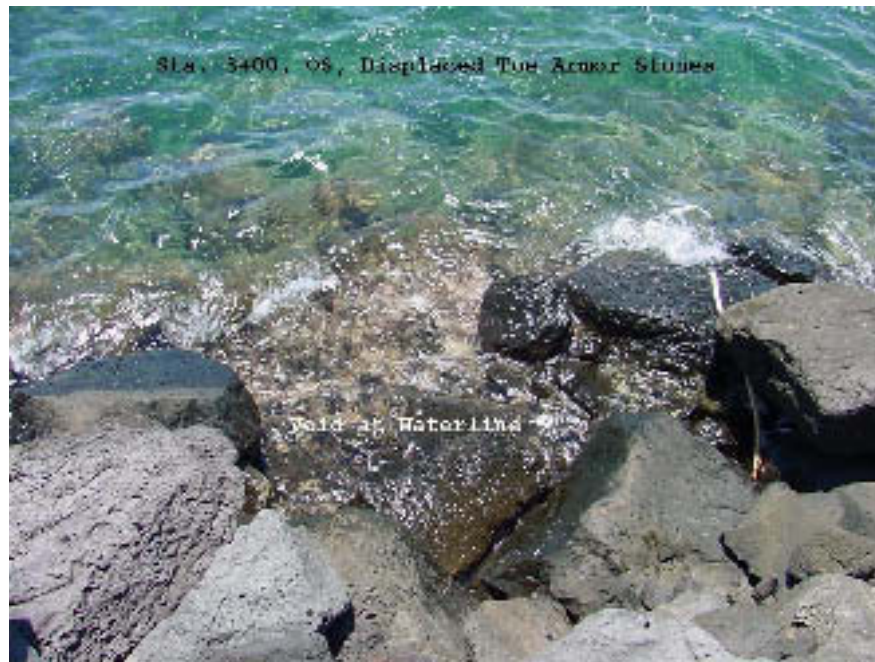
c. Sta. 3+00, OS, Displaced armor stone & exposed underlayer at waterline.

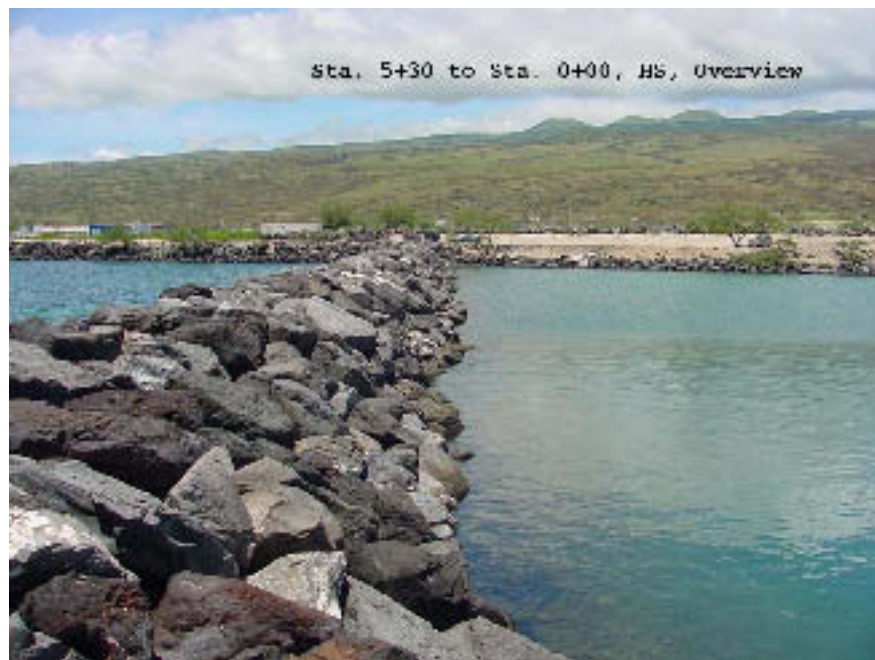
f. Sta. 5+30, HS, Photo for reference.

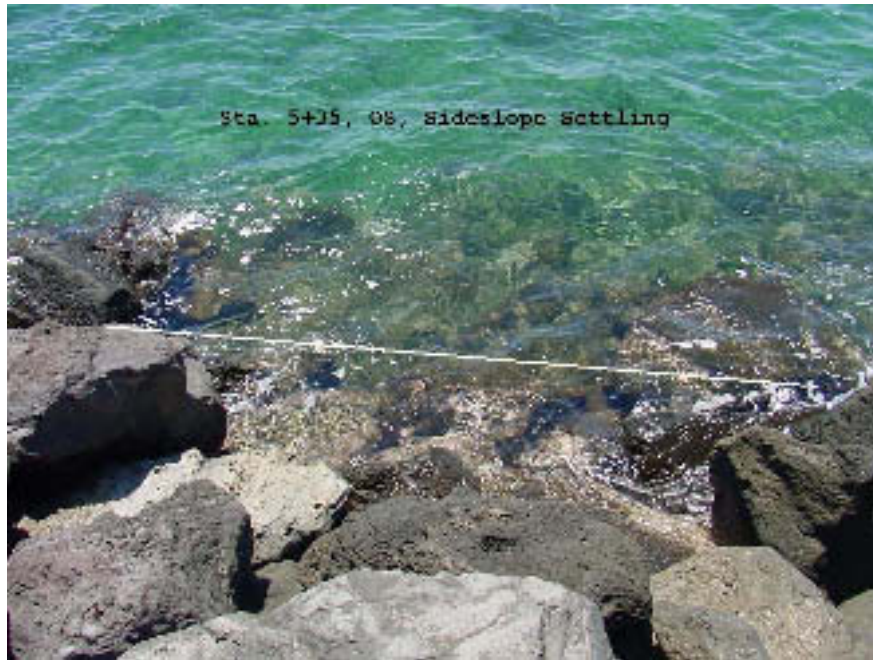
g. Sta. 5+35, OS, Possible sideslope sliding, dislocated armor stones, void.

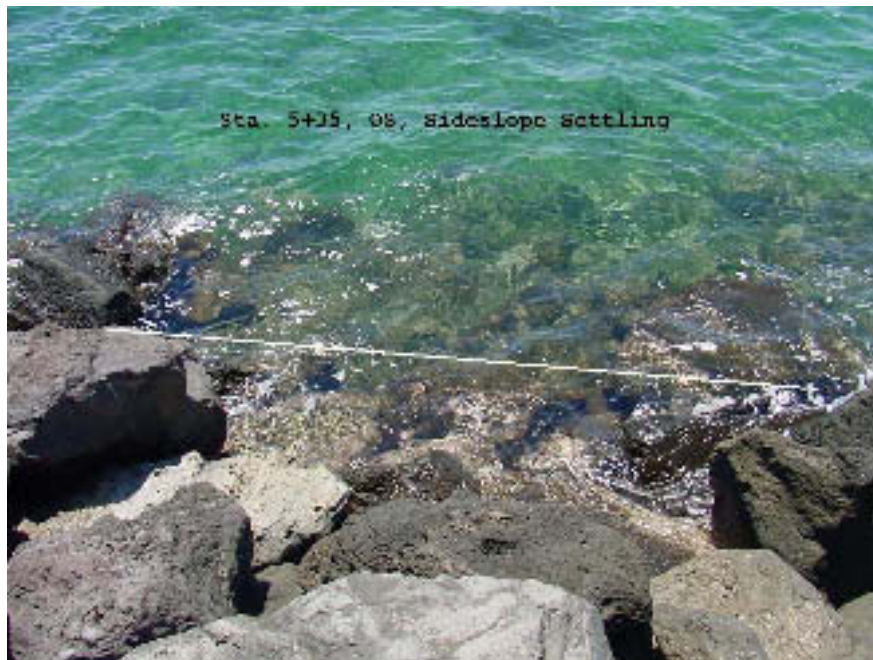
h. Sta. 5+35, OS, Sideslope settling, armor stones missing.

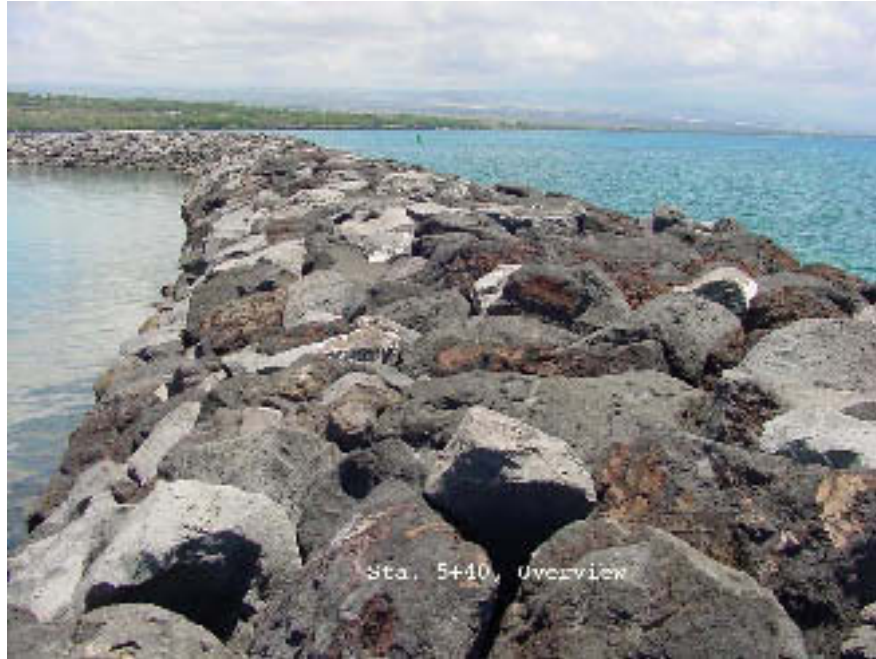
i. Sta. 5+40, Overview photo for reference.

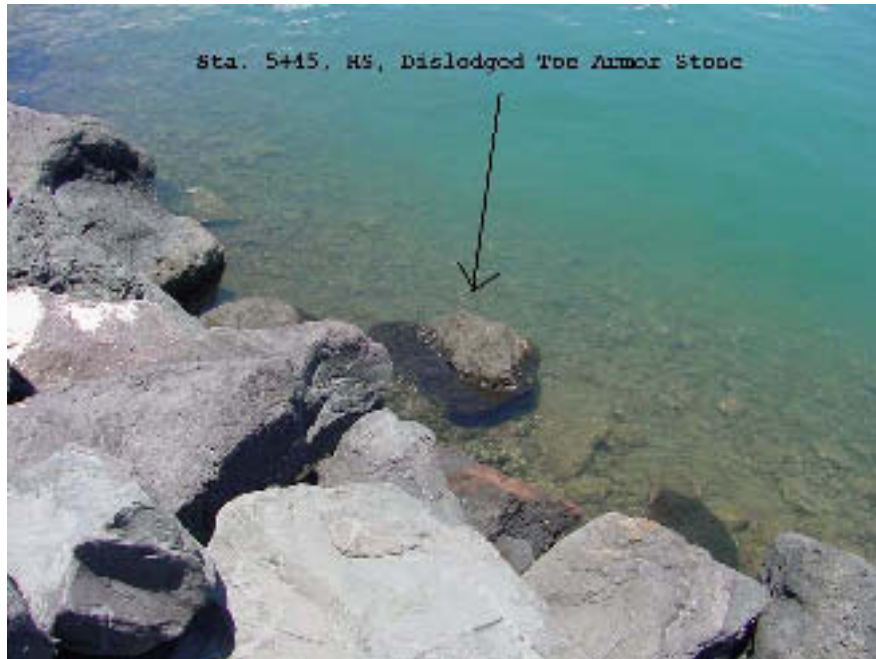
j. Sta. 5+45, HS, 1 ea. dislocated armor stone at toe.

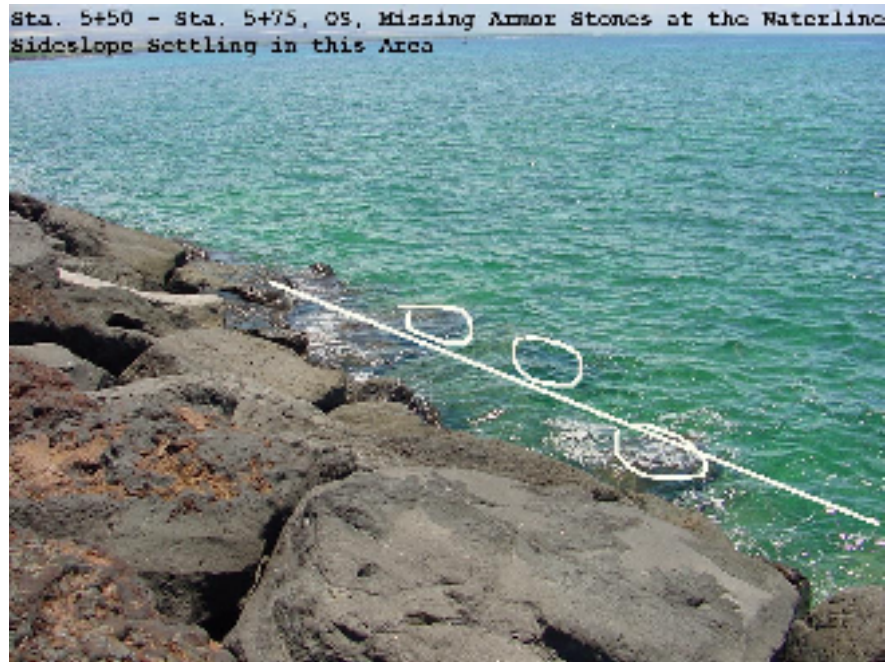
i. Sta. 5+50 - Sta. 5+75, OS, Possible sideslope failure, toe stones missing, void, approx. 20LF.

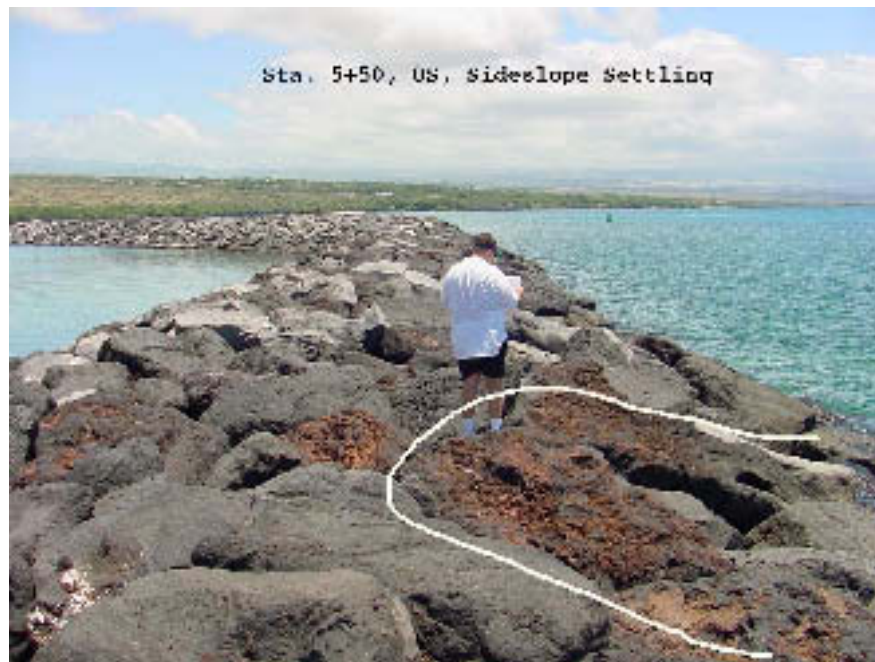
i2. Sta. 5+50 - Sta. 5+75, OS, Possible sideslope failure, toe stones missing, void, approx. 20LF.

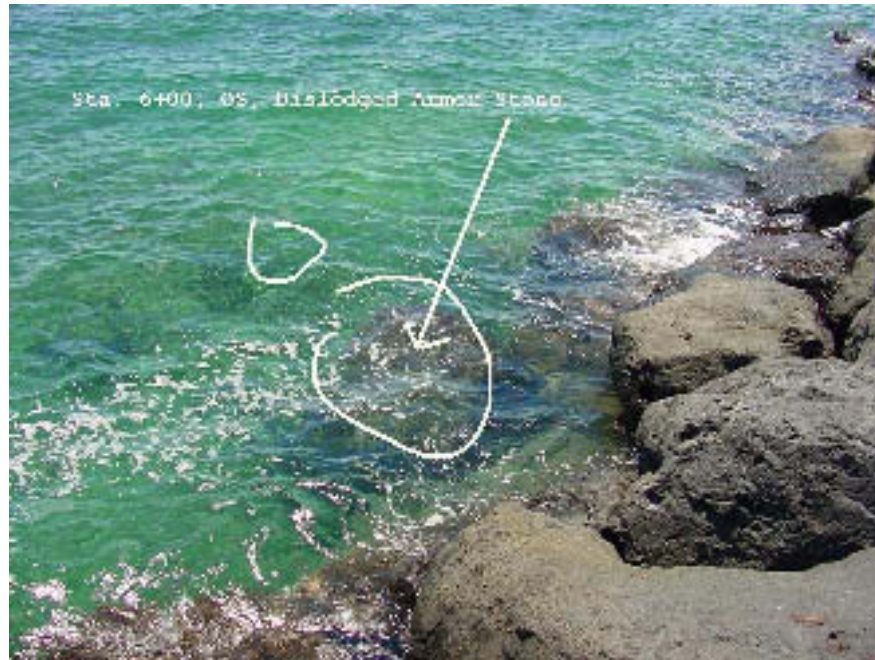
k. Sta. 6+00, OS, Dislodged armor stone @ toe, cavity/void.

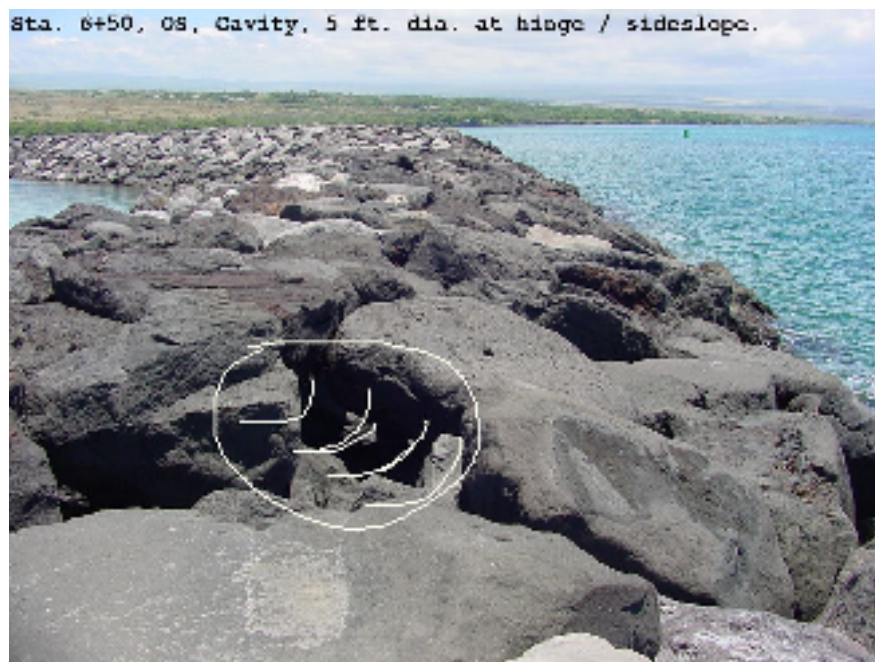
- l. Sta. 6+50, OS, Cavity, five foot dia., sideslope steeping.
- m. Sta. 7+10, OS, Bridging of armor stone, large cavity.
- n. Sta. 7+50, OS, 1ea. 12T armor stone dislodged.

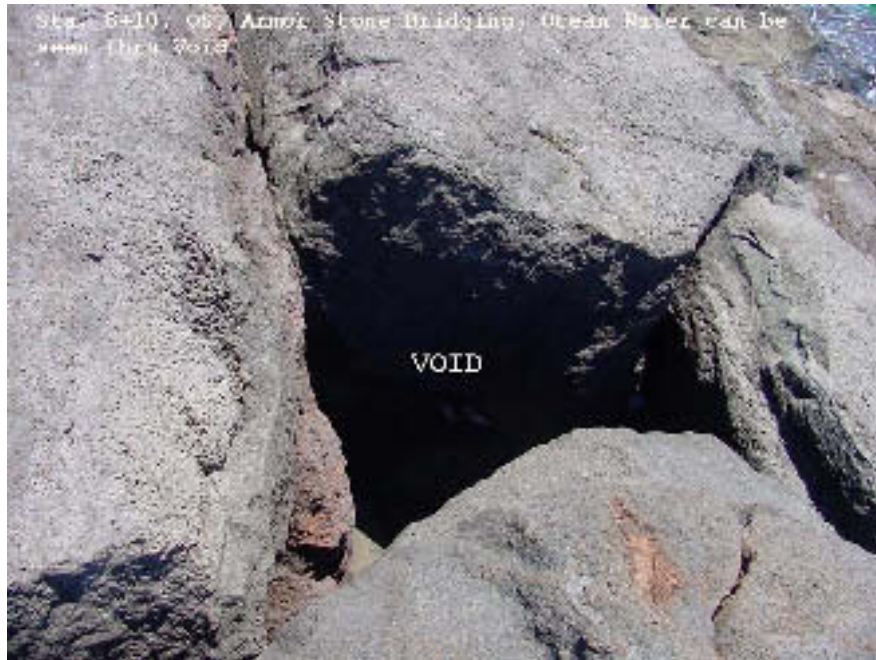
q. Sta. 8+10, OS of crest, large void.

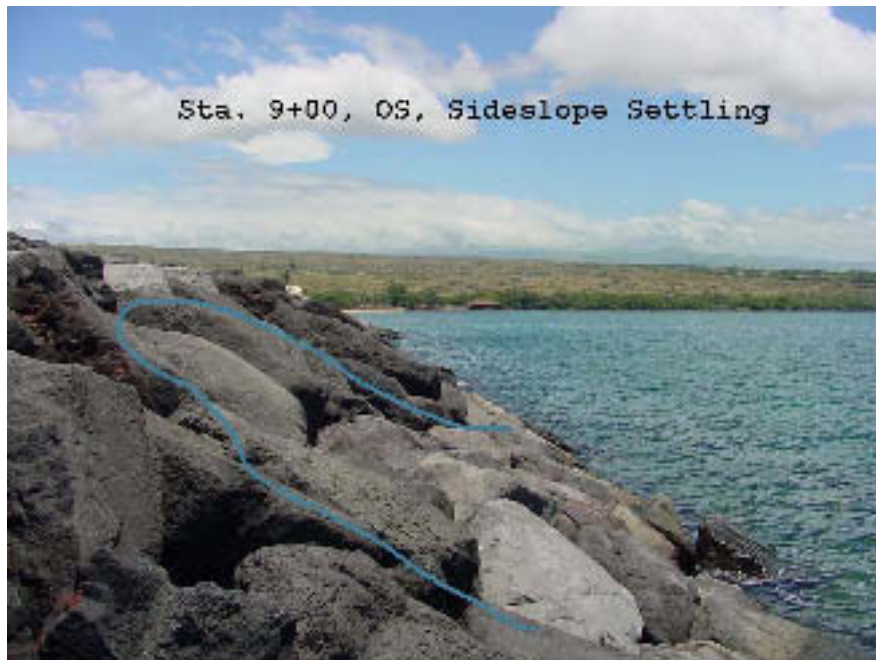
s. Sta. 9+00, OS, Settling of sideslope.

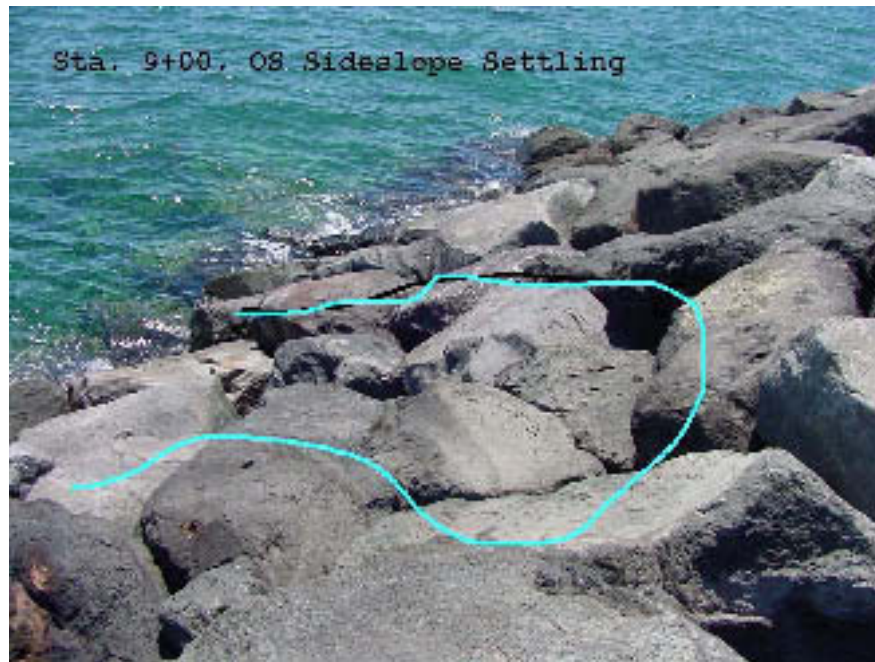
s2. Sta. 9+00, OS, Settling of sideslope.

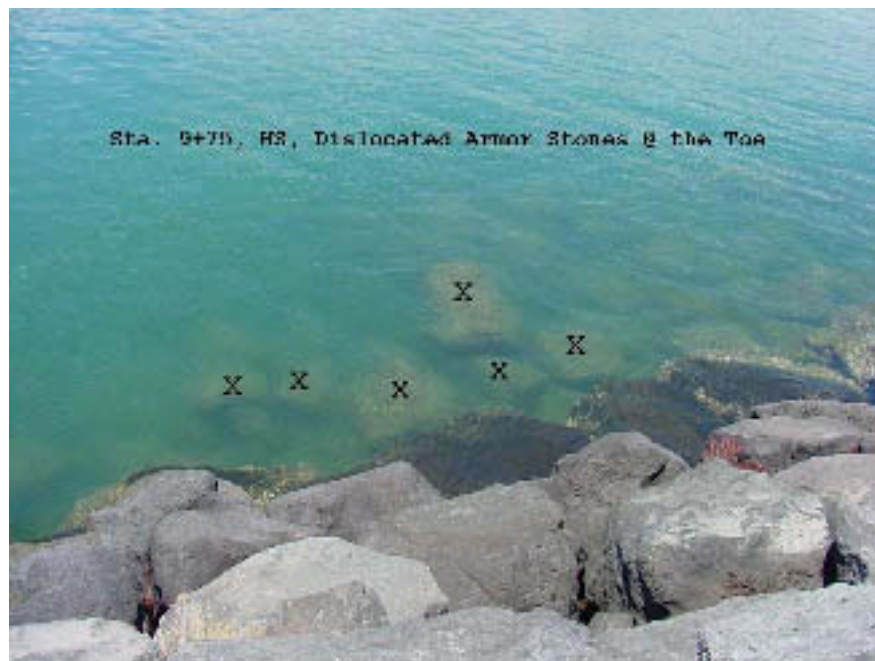
t. Sta. 9+45, HS, Several dislocated armor stones.

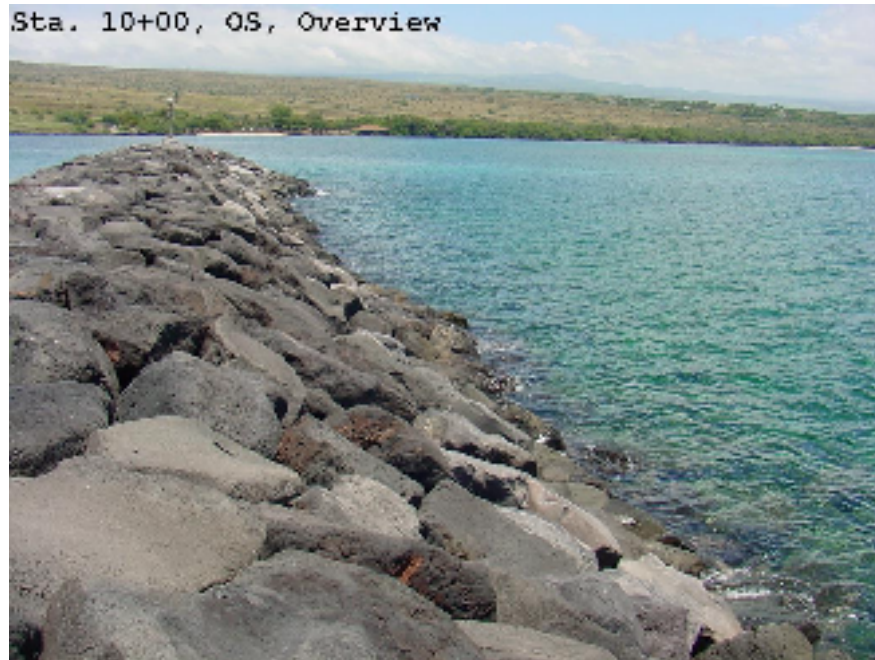
u. Sta. 10+00, OS, Overview photo for reference.

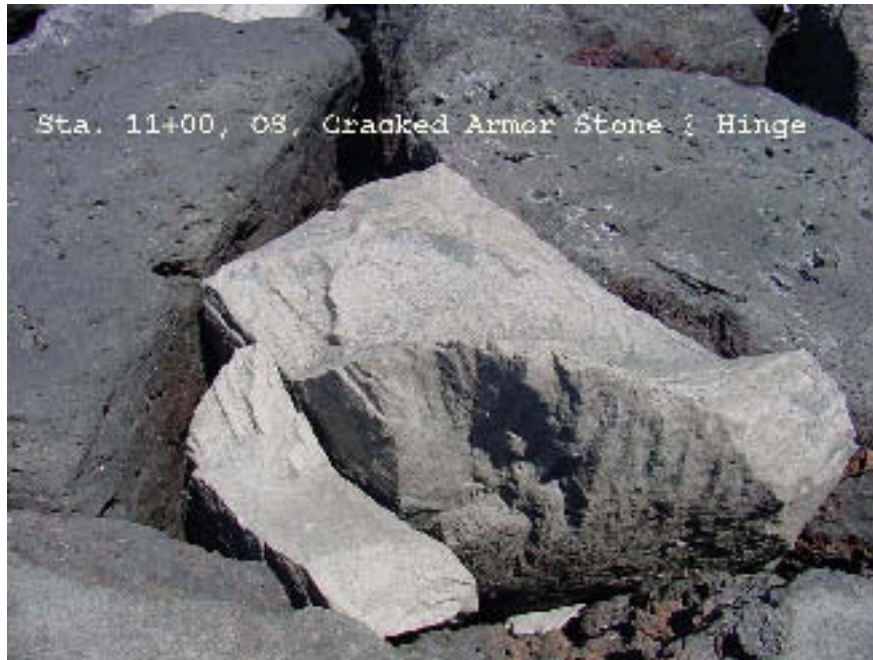
- x. Sta. 11+00, Crest, Cracked armor stone.
- y. Sta. 11+00, HS, Chinker 2/3 up the sideslope, no bottom contact.
- z. Sta. 11+20, HS, 3ea. chinkers, one 12T-15T armor stone bridging.
- aa. Sta. 11+50, OS, 2ea. armor stones at waterline dislodged.
- bb. Sta. 12+15, OS, Armor stone larger than specified in the contract specs, 15T-18T.
- cc. Sta. 12+20, OS, 1ea. armor stone bridging.

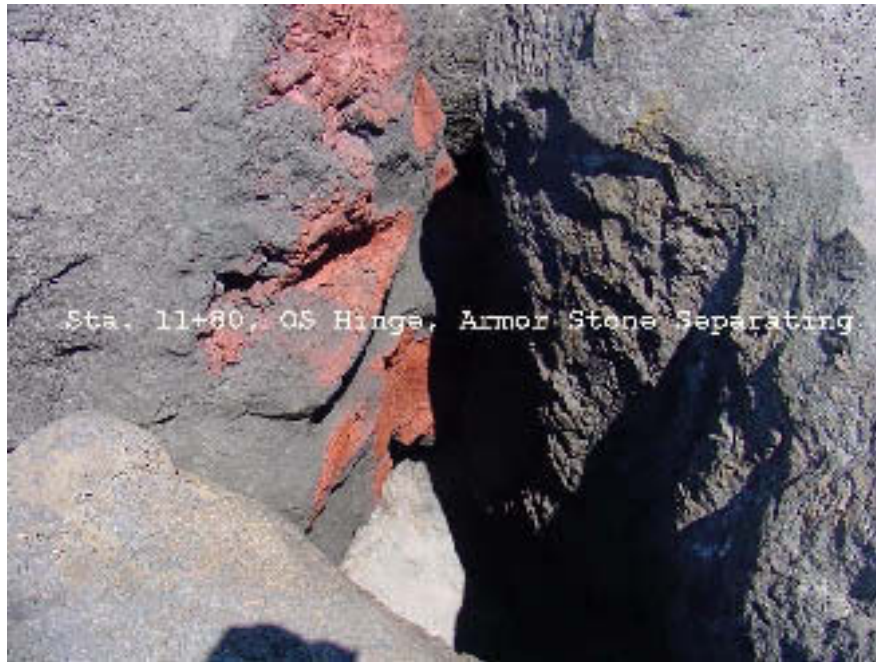
dd. Sta. 11+80, OS hinge of crest, Armor stone separating.

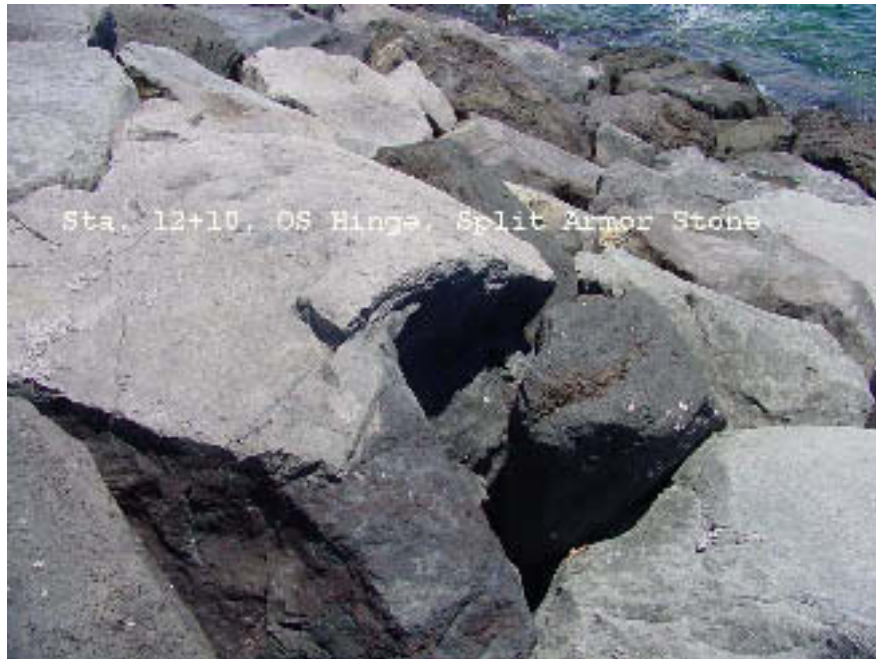
ee. Sta. 12+10, OS Hinge, Split armor stone.

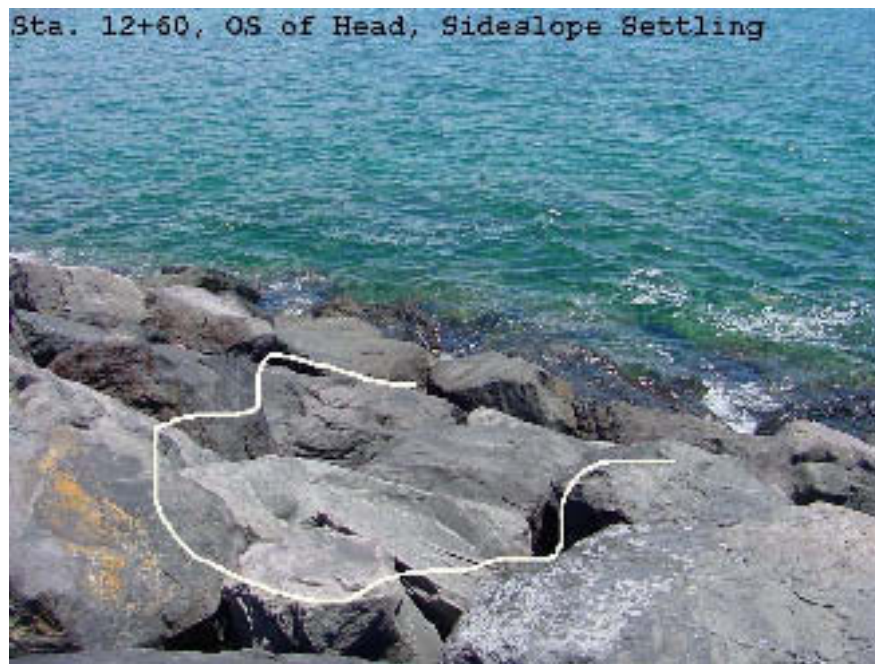
ff. Sta. 12+60, OS Head, Sideslope settling.

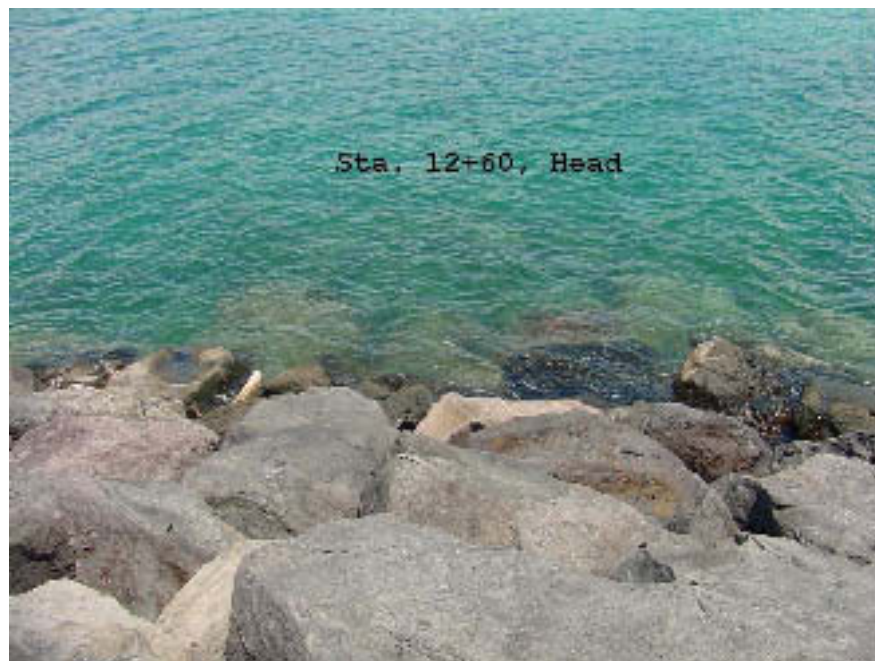
gg. Sta. 12+60, Head, 0 deg., Possible 8' void at the head's waterline.

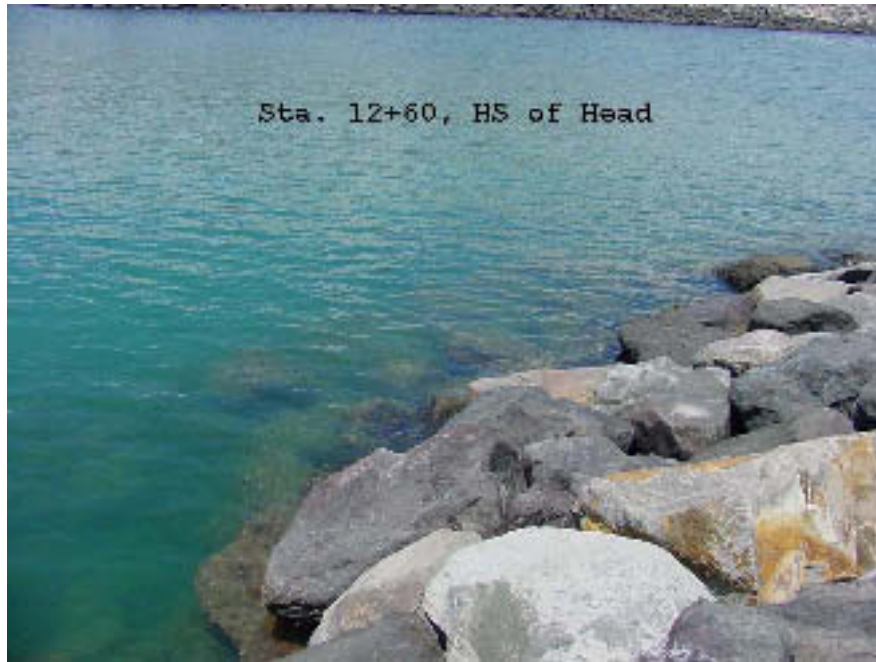
hh. Sta. 12+60, Head, 45 deg., HS, lea. armor stone bridging.

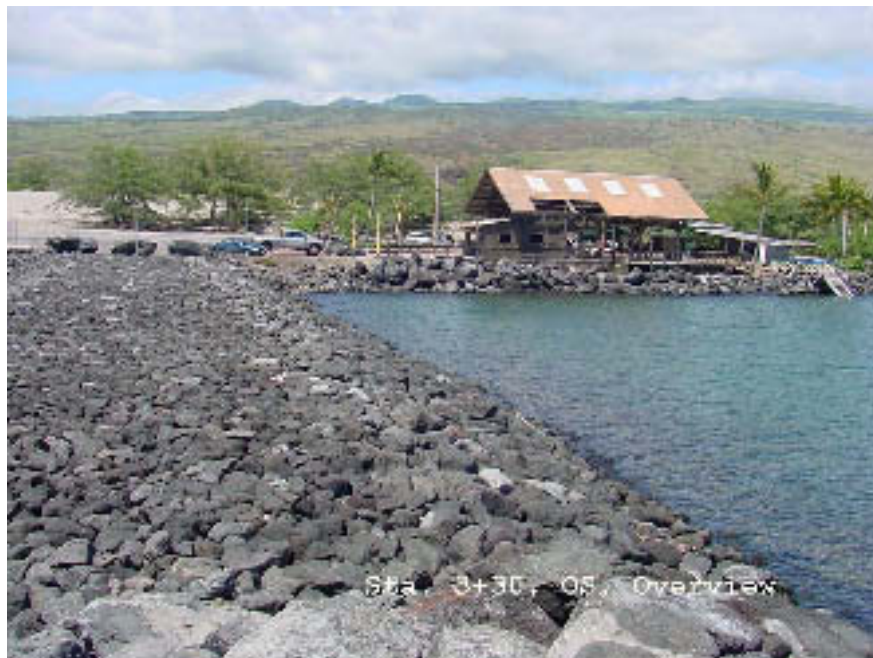
c. Sta. 2+80 to 4+00, OS, Monitor minor settling on sideslope.

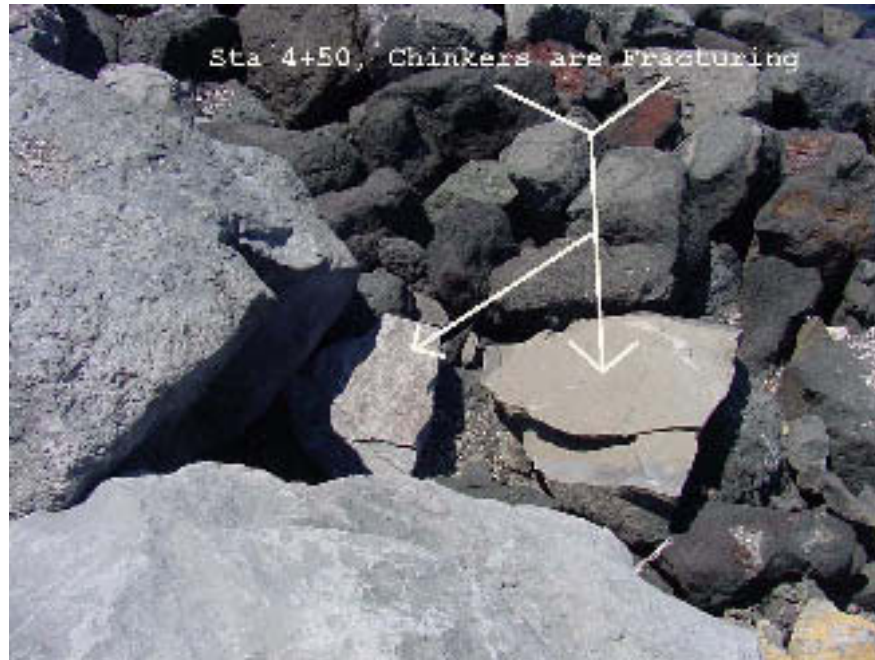
f. Sta. 4+50, HS, Chinkers have begun to break due to weight of armor stone.

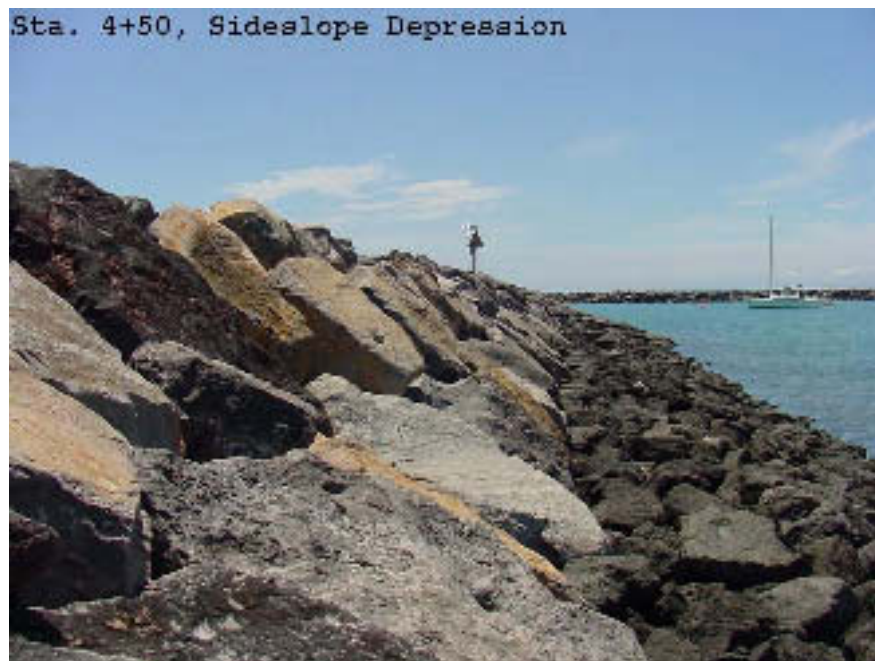
g. Sta. 4+50, HS, Chinkers have begun to break due to weight of armor stone, sideslope beginning to separate @ the hinge and creep @ the toe.

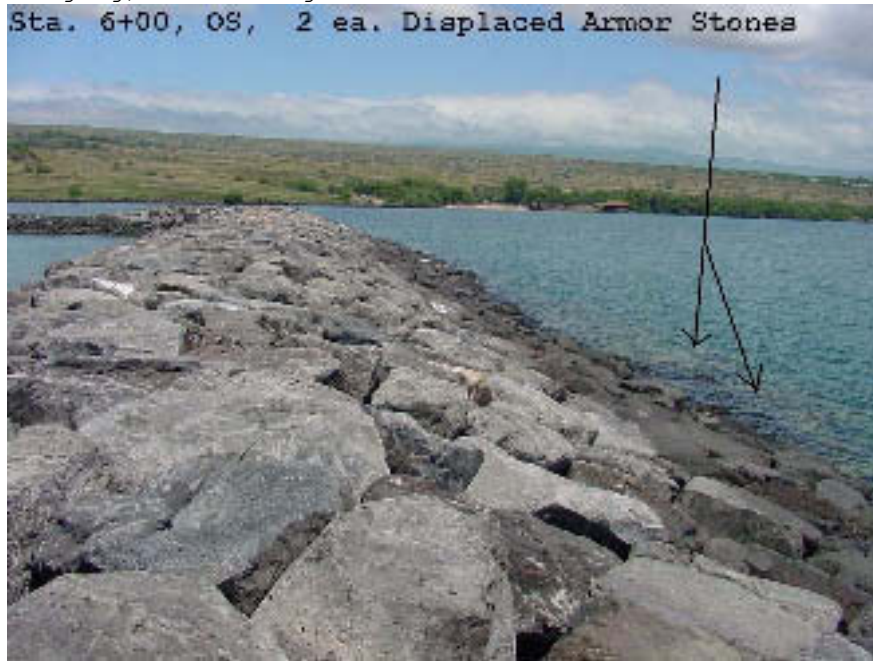
- h. Sta. 6+00, OS, 2 ea. armor stones are displaced @ the toe.
- i. Sta. 6+80, 2 ea. armor stones are flipped @ the toe.
- j. Sta. 7+80, 0 Deg., 1 ea. armor stone dislodged @ toe.
- k. Sta. 7+80, OS of Head, 9pm, 4-5 ea. armor stones are dislodged and separated from the toe.
